PRELIMINARY PROTECTED SPECIES ASSESSMENT

Deva Aberystwyth, Ceredigion

Report Reference – WWE/Bats/250920b

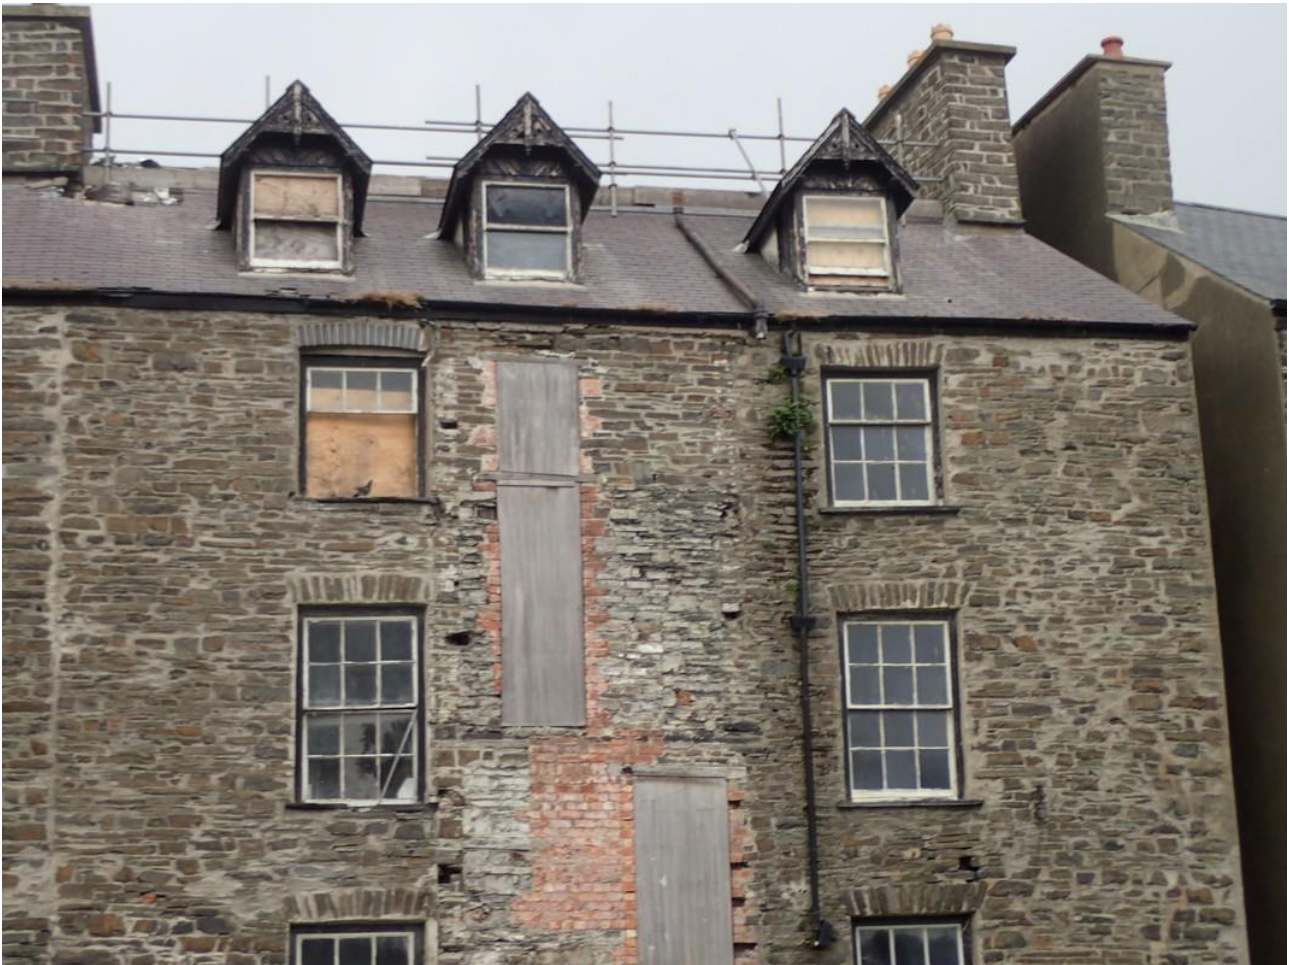
No signs of bats were found within the building, but potential bat access points were noted via missing slates on one side; cavities in the stone-walls on this side also have some potential to support low numbers of roosting bats. At least one bat activity survey, not now possible until May 2021, will be required before the proposed work could proceed.

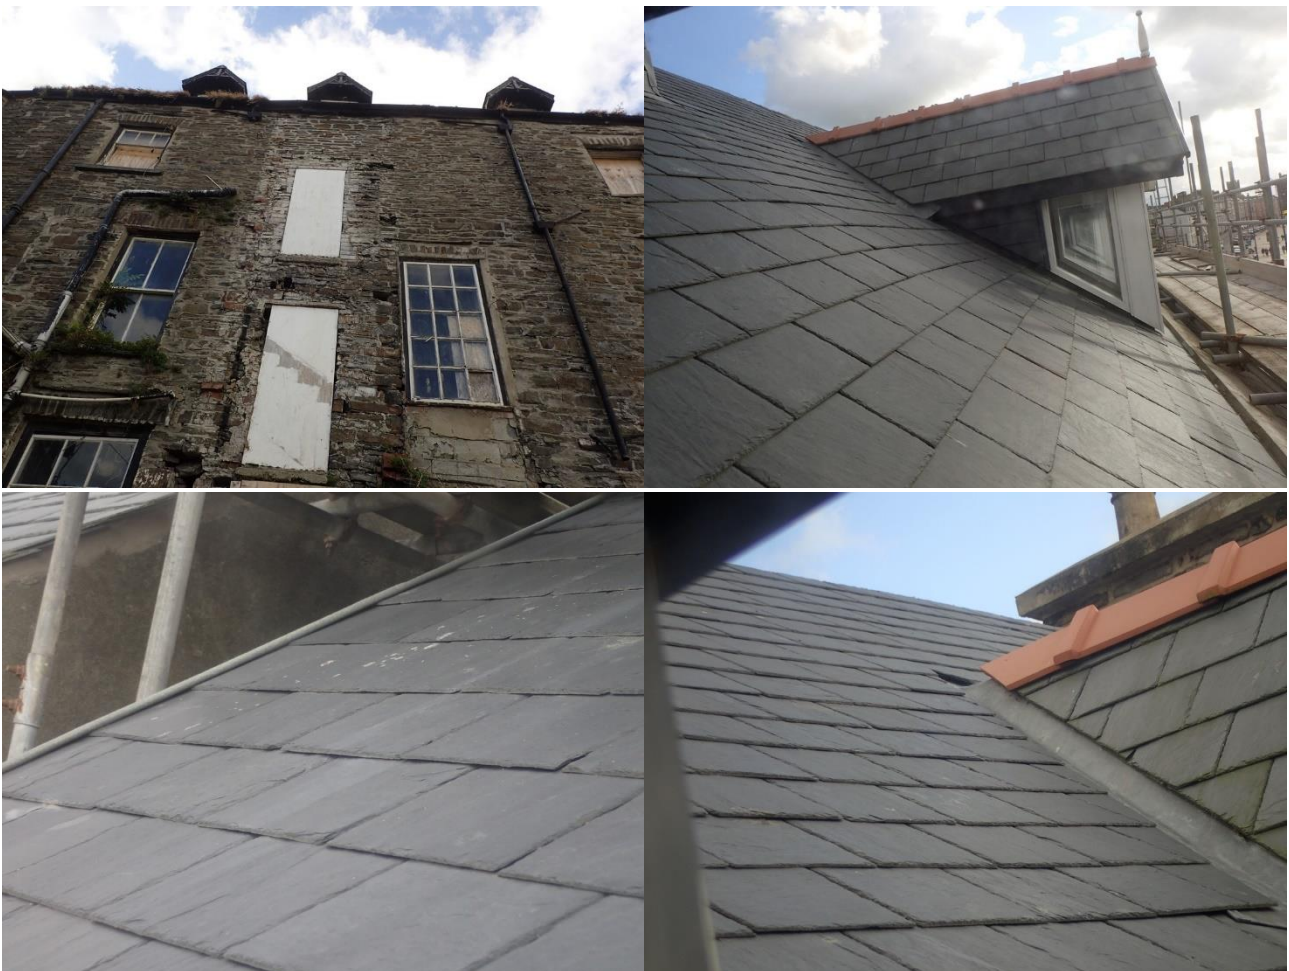
The external photos below illustrate the roof and wall structures. The west-facing section of the pitched roof has been re-roofed relatively recently, with new slates, solid insulation and a well-fitted breathable membrane below. The east-facing section has older slates with a bitumen felt membrane below the supporting battens; tears in the felt showed that there is no insulation above.

External photographs (clockwise from top-left): rear of building; dormer window on front of building; slate roof and dormer window; slate roof detail

The front external wall is blockwork, rendered and painted, affording no crevices. The rear of the building has a mortared stone wall, with some central sections around windows repaired in brick.

Junctions with dormer windows on the rear side of the building appeared to be poorly sealed; those on the front of the building could not be seen clearly. The junction between slate roof and southern chimney is poor, and the roof is damaged adjoining this, with some slates missing. One other individual missing slate was noted below a dormer window. The fascia board on the rear of the building is wooden and not tightly fitted to the wall top. The chimneys to either end appear to be of sound construction. Some original windows are intact, others are boarded. The upper level comprises a large attic room with dormer windows to either side. Those to the rear have wooden frames protruding over the windows. Internal walls are stone and only partly mortared.

Potential access points for bats were apparent in several places. Missing slates on the roof to the rear of the building would afford access into the void between slates and bitumen felt. The ridge line currently lacks ridge tiles, and light was visible through the gap between membranes to either side. There is a missing window on the ground floor to the rear of the building, and a higher window showed a gaps between boarding and glass. The fascia board on the rear roof-top is not tightly sealed to the stone-work, which looked potentially to be poorly-mortared here. The stone-work lower down the rear wall has occasional cavities formed by missing stones and bricks. Internally, the building has no enclosed spaces suitable for a significant roost; but crevices in the stonework on either gable end appear to have some minor potential to be used as roost spaces by low numbers of bats.

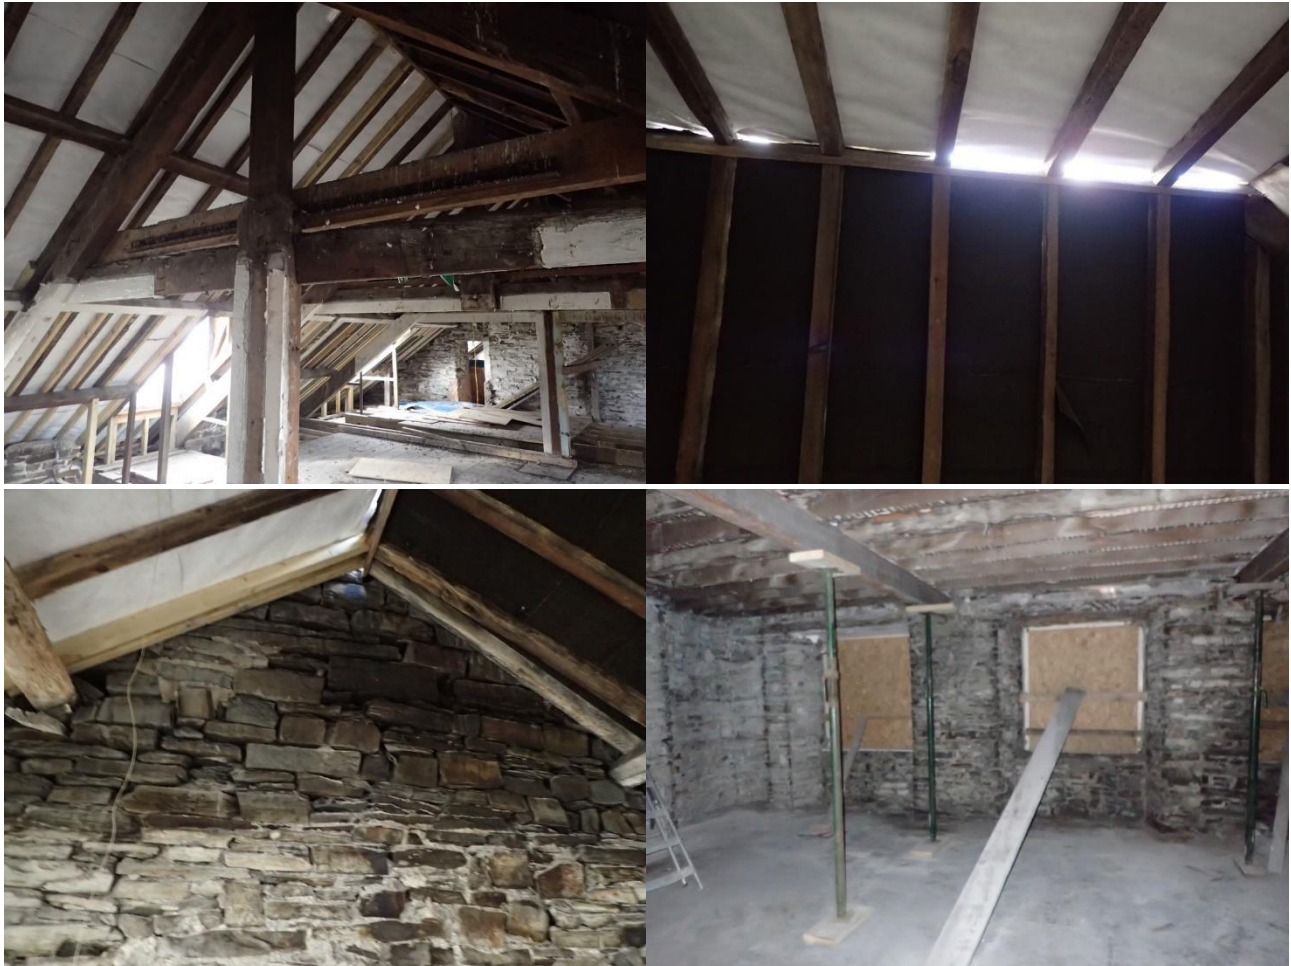
Internal photographs (clockwise from top-left): Upper storey; currently un-tiled ridge showing newer (white) membrane and older (black) bitumen membrane; ground floor; crevices in internal gable-end wall

The survey concluded that bats have some potential to access the building, or use features on the roof and rear wall. At least one activity survey will be required, and this would not be possible until early May 2021.
